# Cooke's Hollow

## Feasibility Study and Preliminary Design Report

Arlington, Massachusetts

August 2023

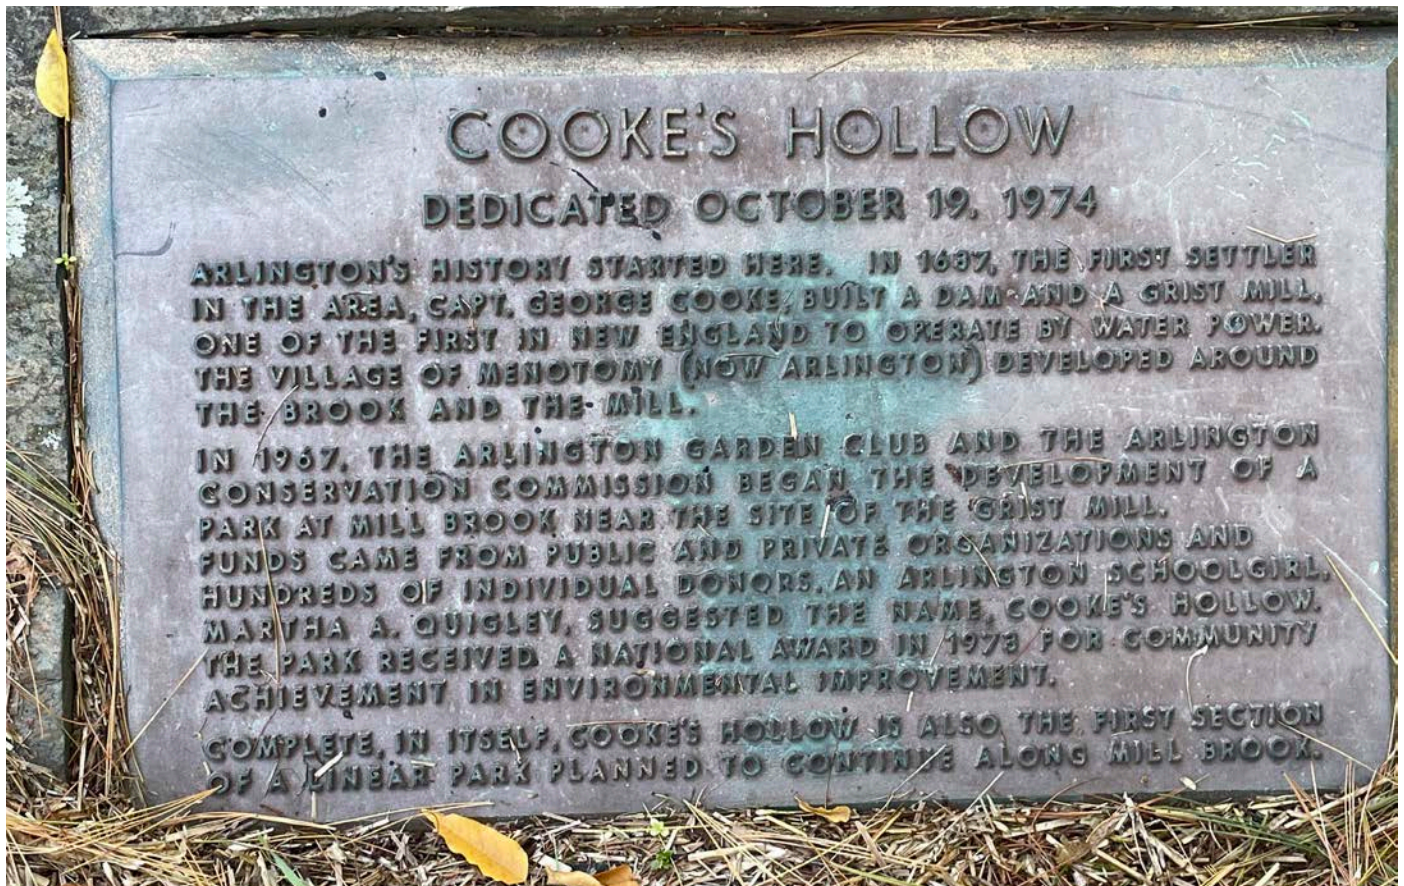
1 Dedication Plaque

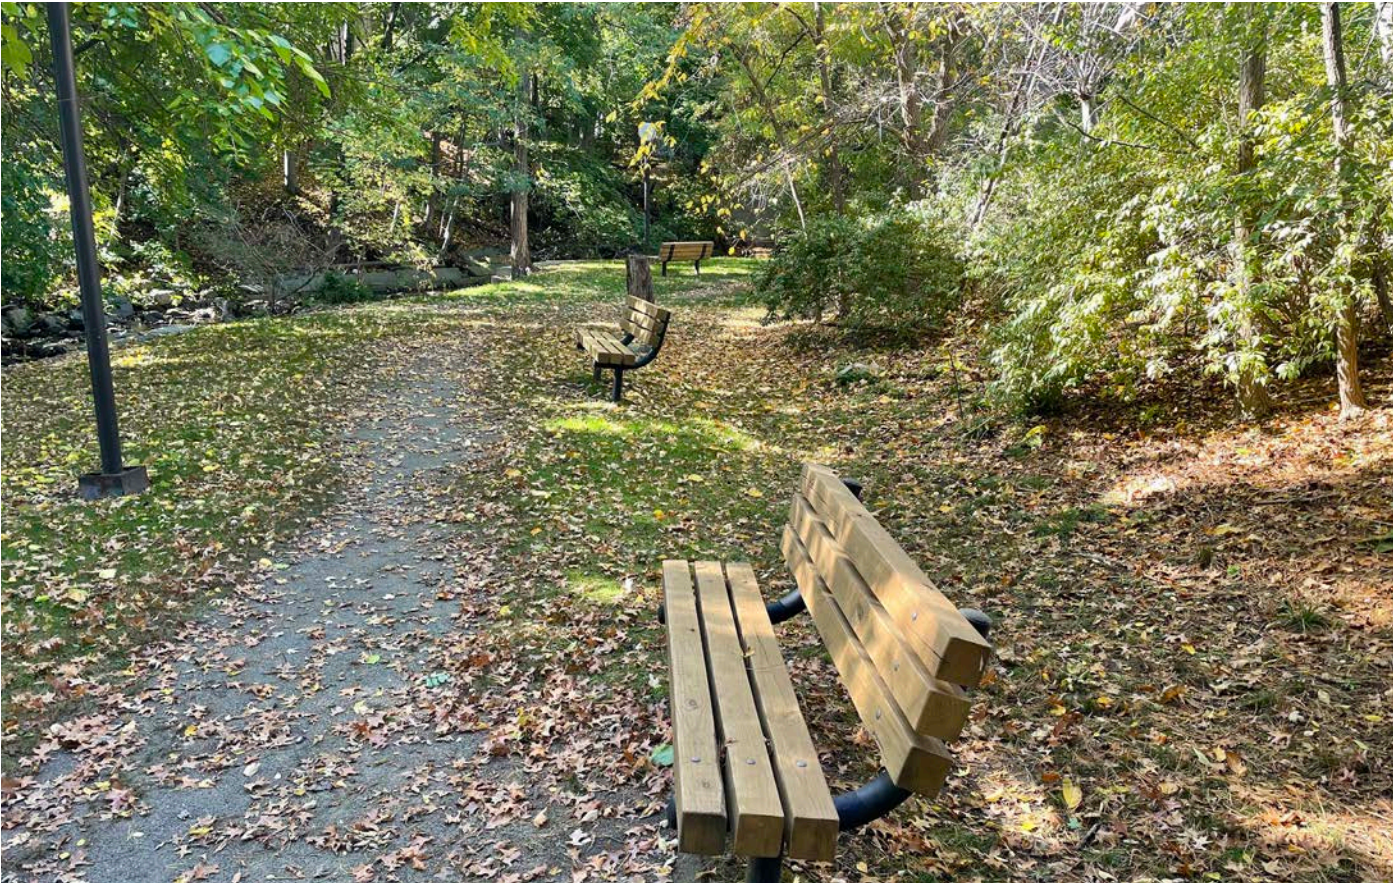
3 Stone Dust Path & Benches

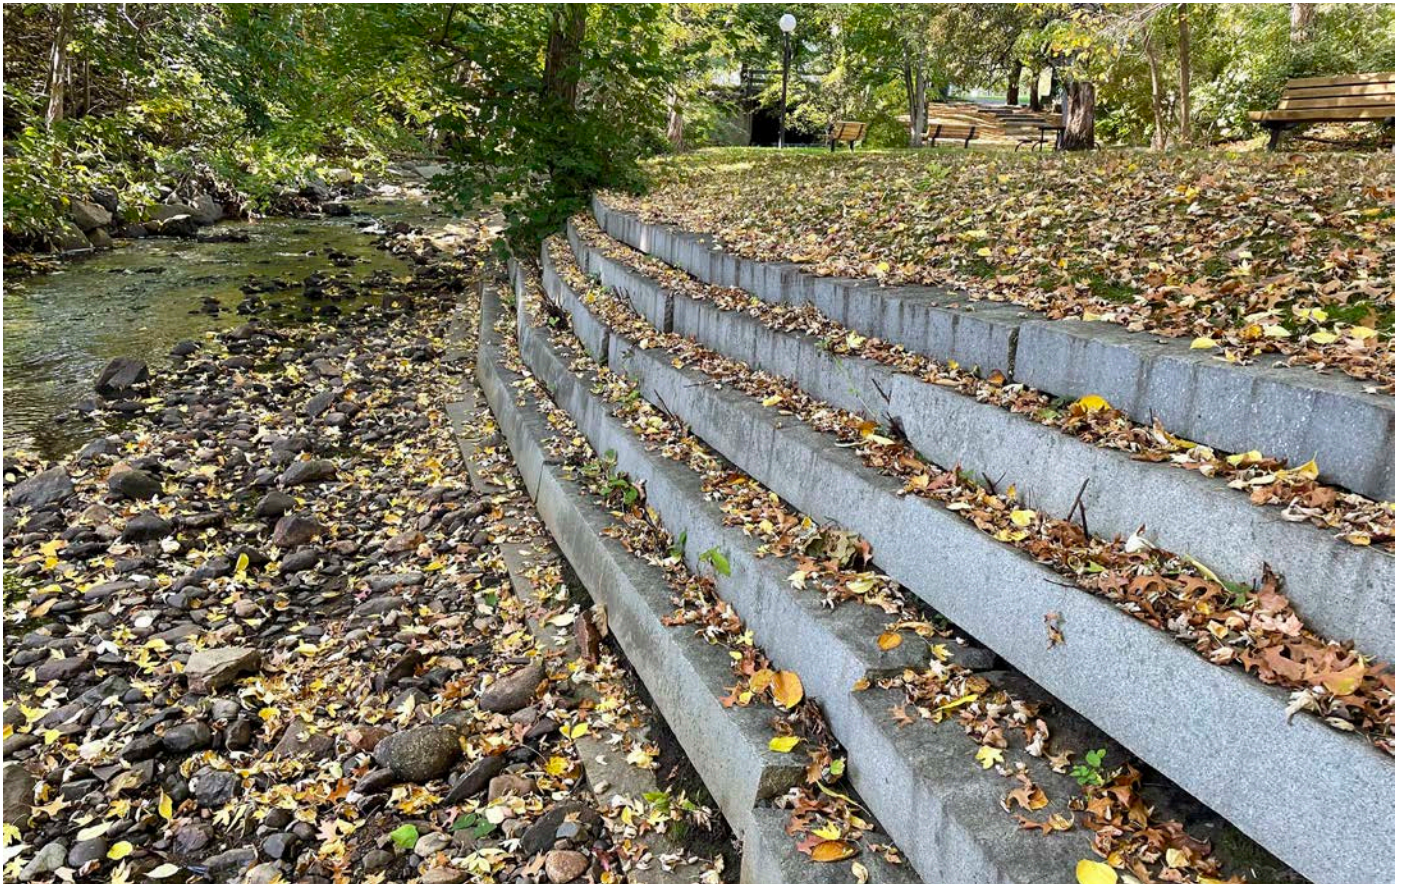
5 Stacked Granite Curb Retaining Edge

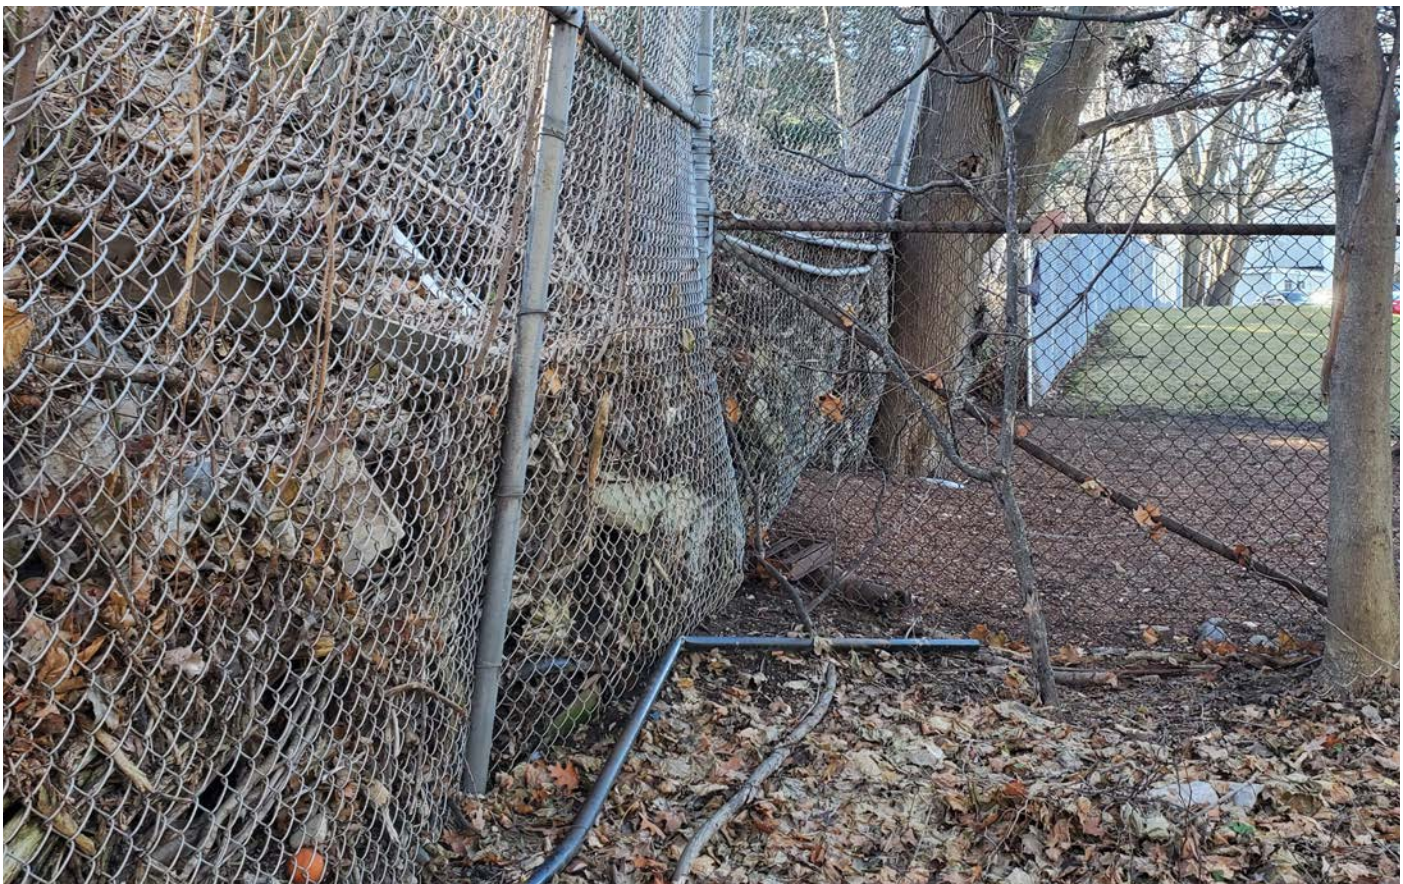
6 Chain Link Fence with Barbed Wire Adjacent to Ball Field

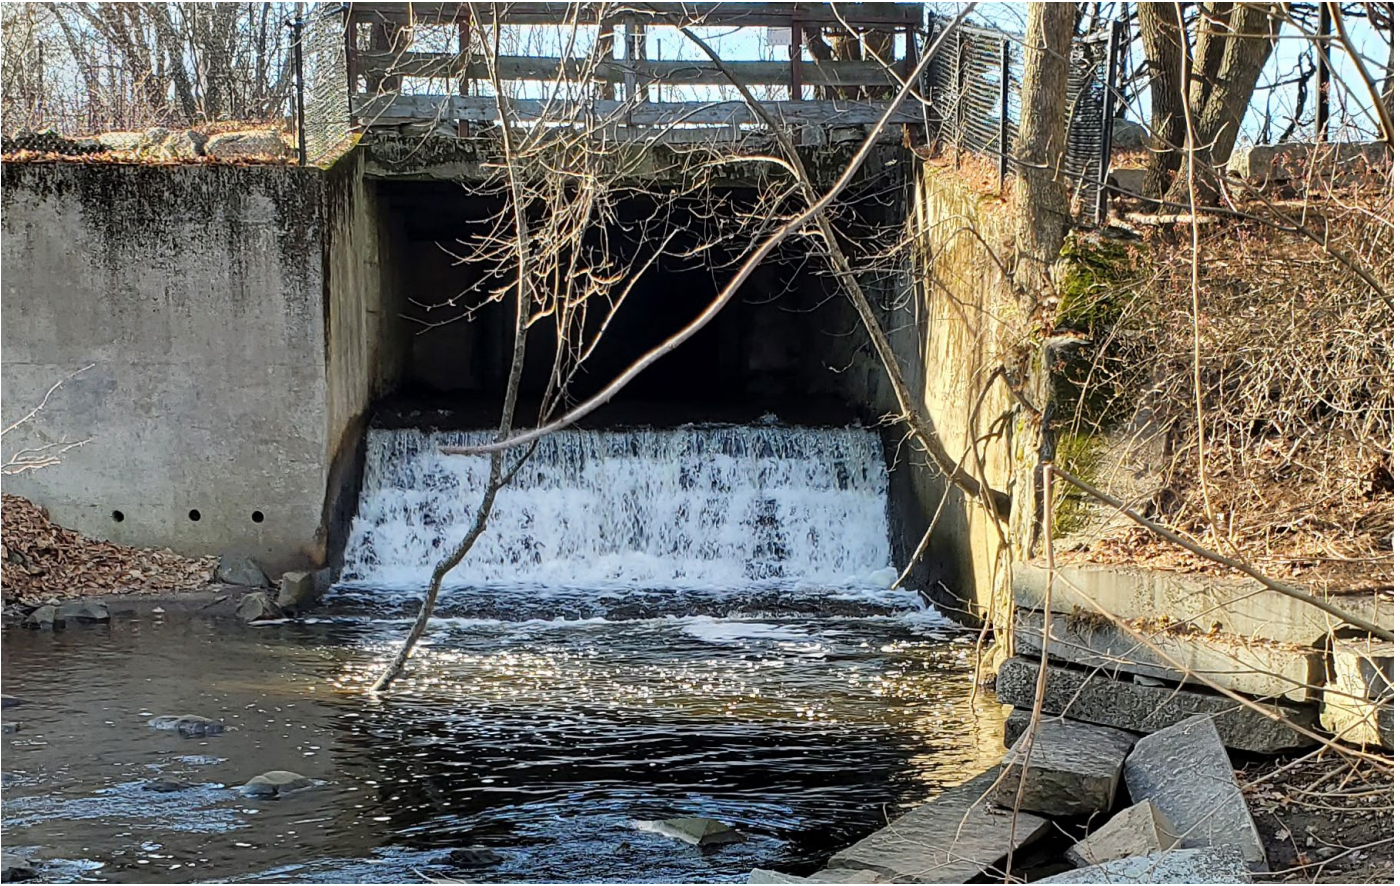
7 View of the Falls from the Bank

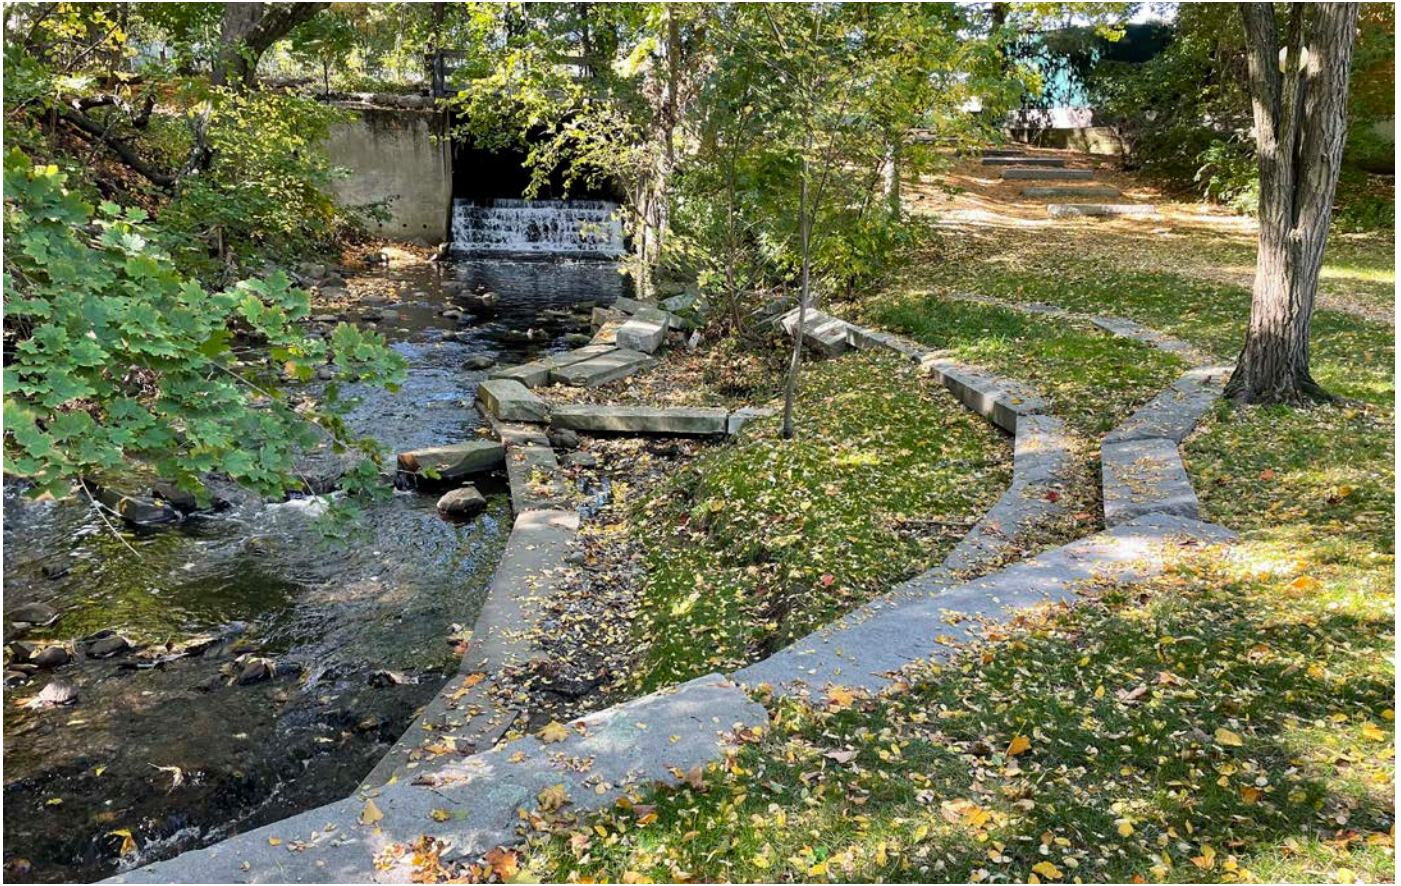
9 Granite Curb Retaining Edge

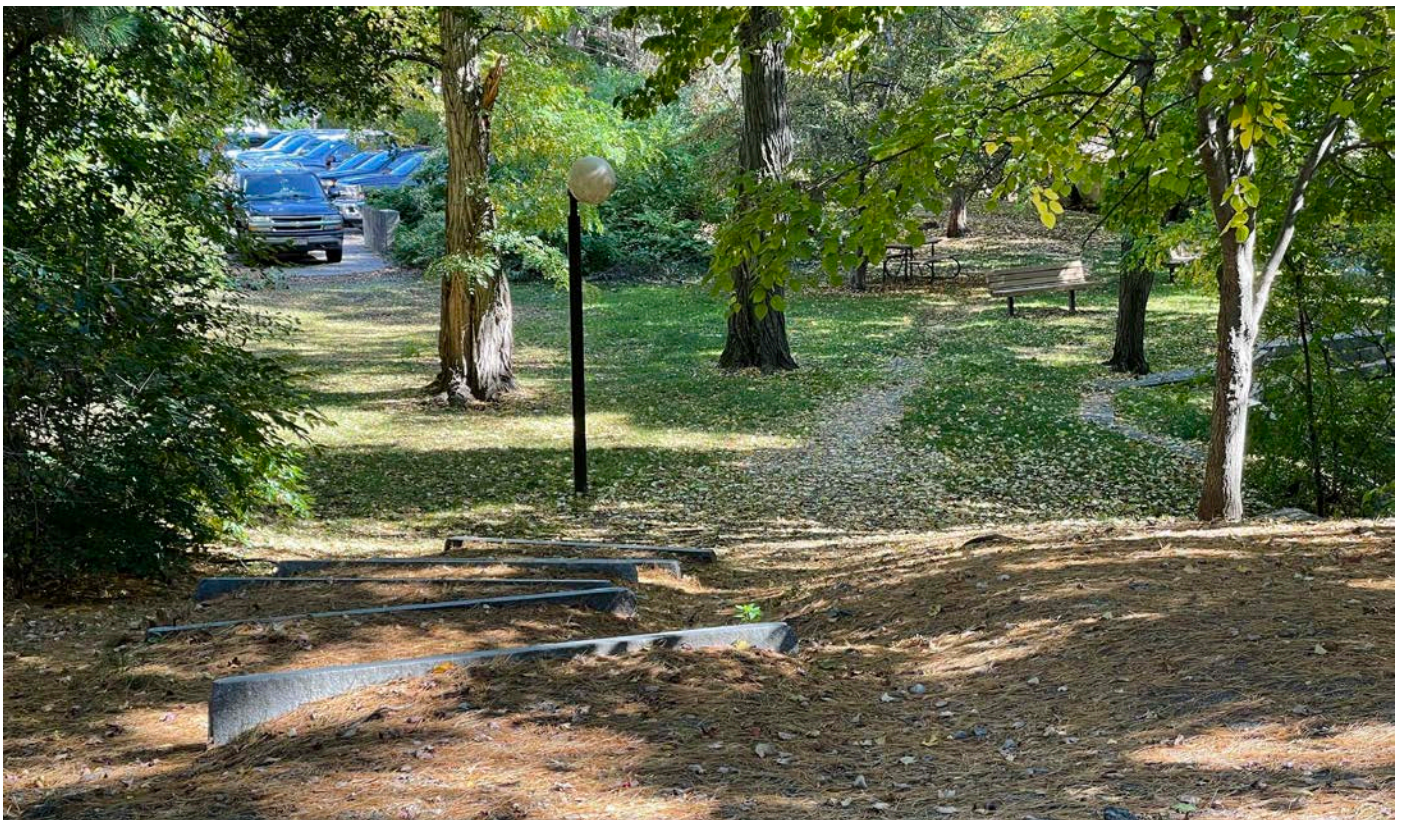
10 View Towards Mystic Street at the Top of the Slope

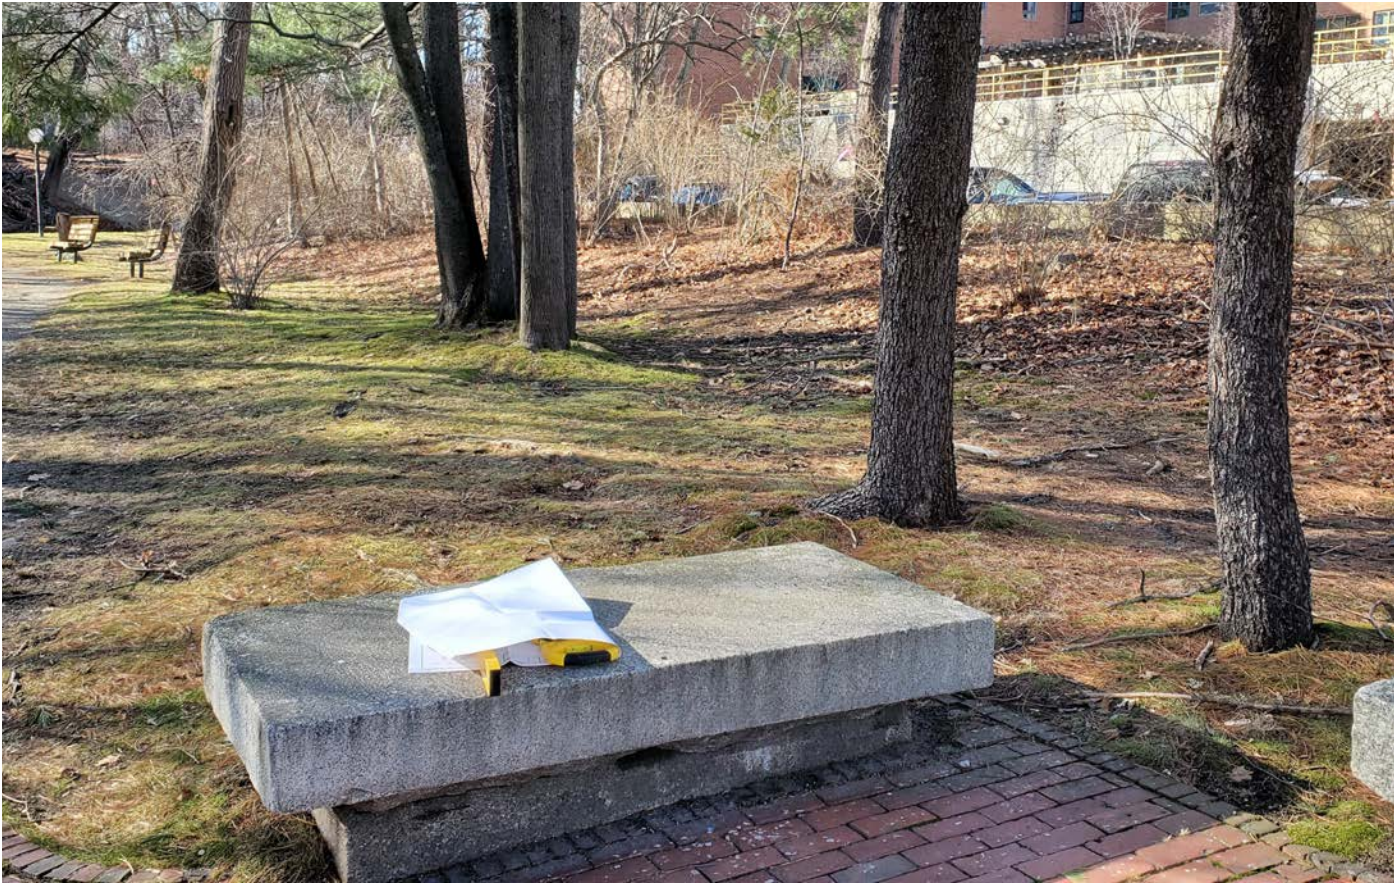
11 Granite Bench at Mystic Street Park Entrance

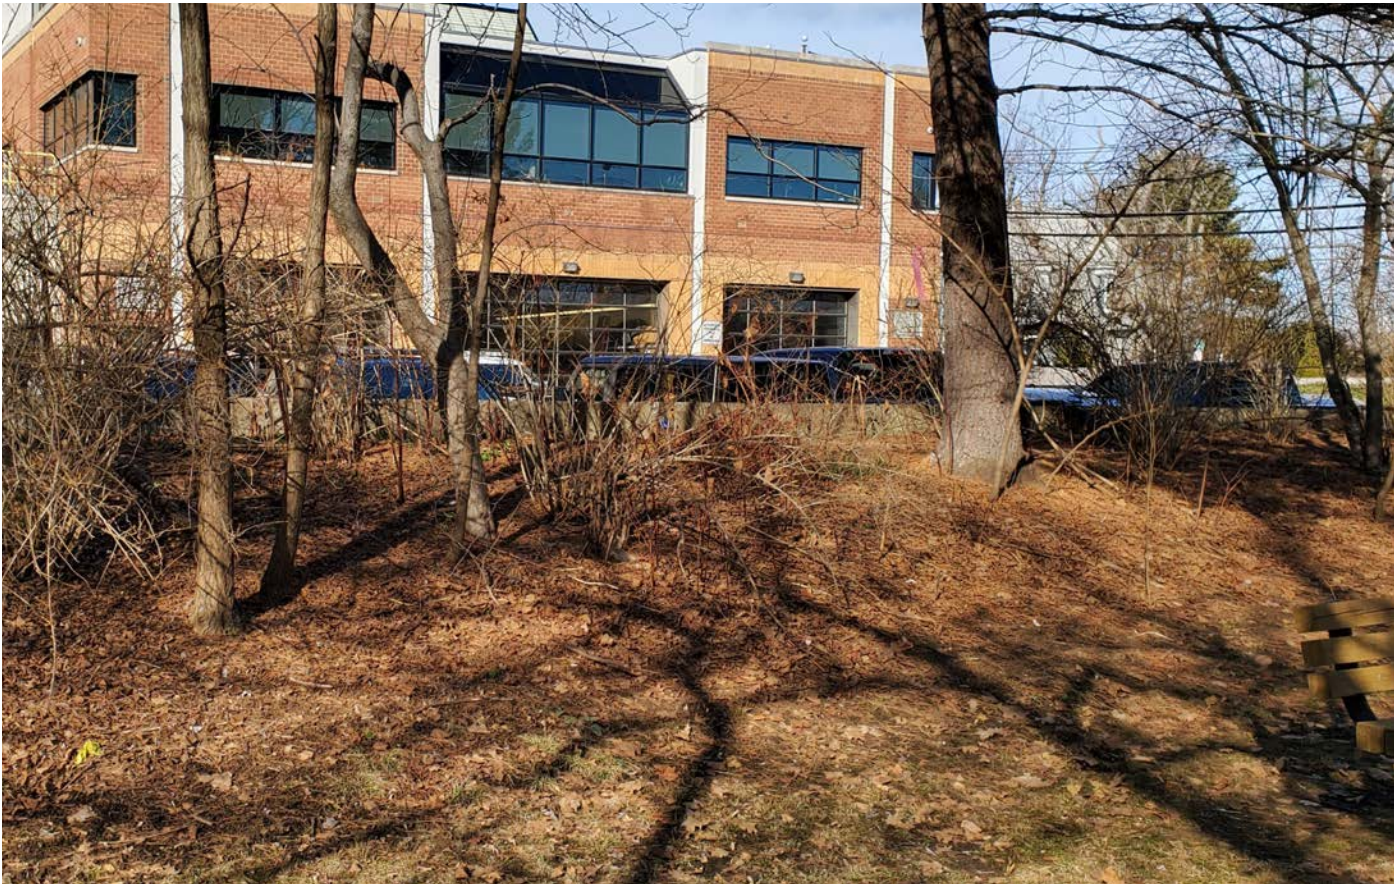
1 Vegetated Buffer Along Police Station Parking Lot Edge

1. SUPPLEMENT BUFFER PLANTINGS ALONG PARKING LOT EDGE.
2. RESTORATION PLANTINGS: NON-NATIVE CLIMATE ADAPTED SPECIES TO BE CONSIDERED.
3. REMOVE ONLY DEAD, DYING, AND SAFETY HAZARD TREES TO BE REMOVED.
4. SOUTH SIDE SLOPE: REMOVE AND DISPOSE ONLY <6" DBH INVASIVE TREES. MATURE SLOPE CANOPY TO REMAIN AS IS.
5. SWALE AND BIORETENTION BASIN.
6. REMOVE ALL STATE-LISTED INVASIVE SPECIES.
7. ADD PLANT BUFFER ALONG FIELD EDGE .
8. SHADE LOVING PLANT BED ABOVE FALLS (DESIGN INPUT AND FUTURE MAINTENANCE FROM GARDEN CLUB).
9. CONSIDER GREEN SCREEN ALONG CUSACK TERRACE EDGE.

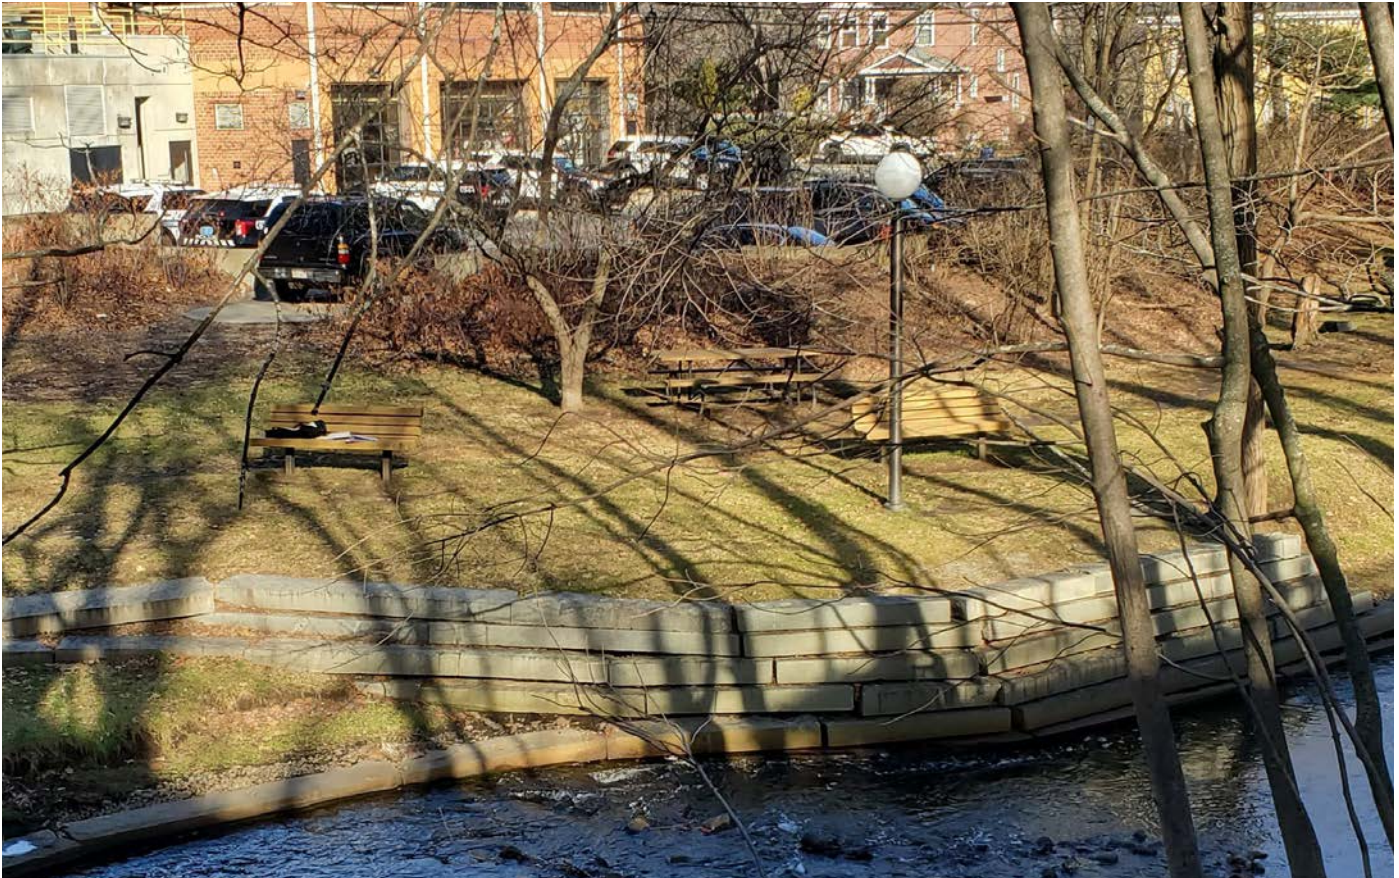
2 Stacked Granite Retaining Edge Along the Main Path

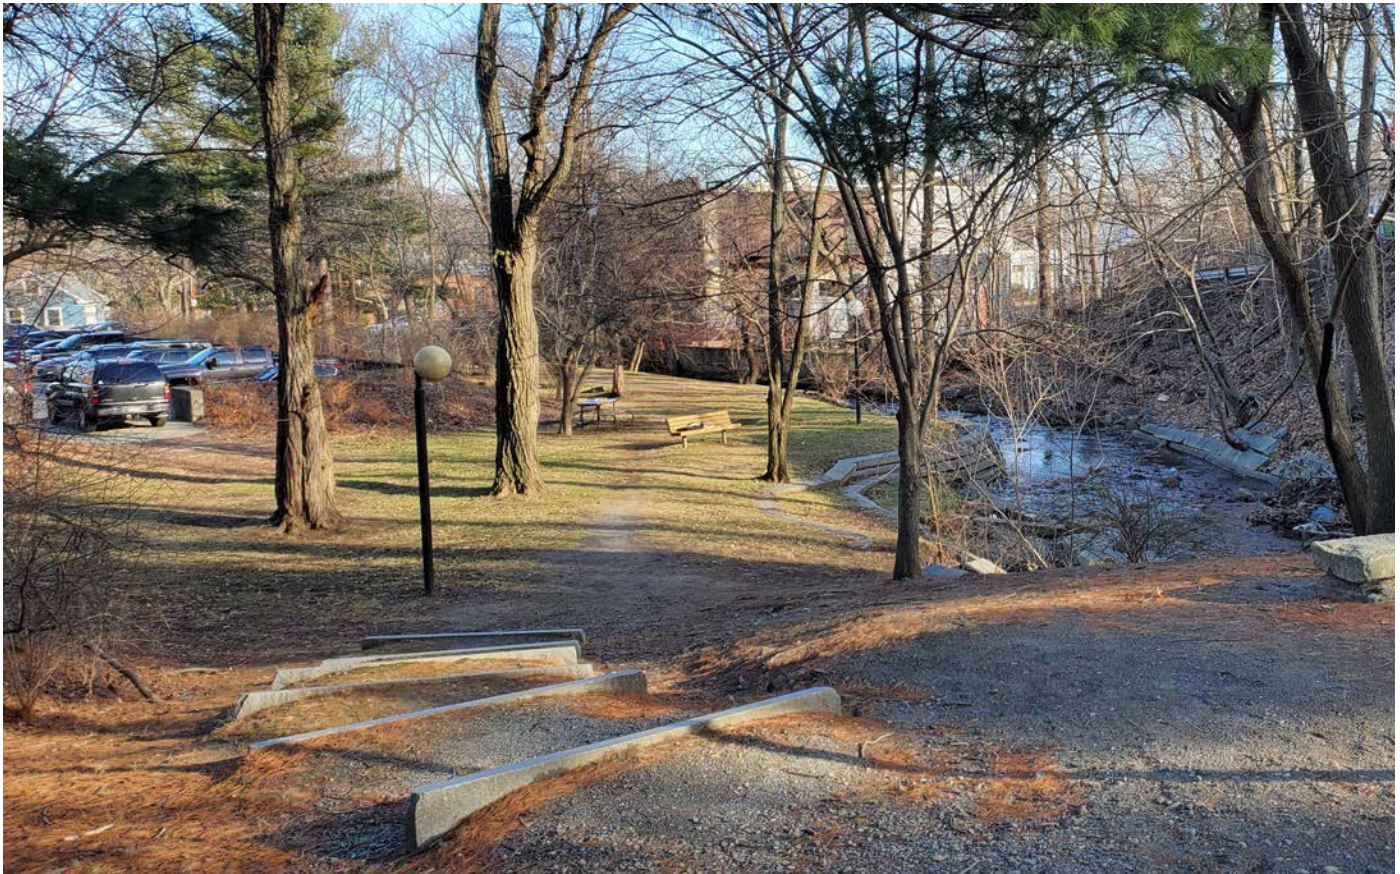
4 View East from the Upper Landing at Top of the Falls

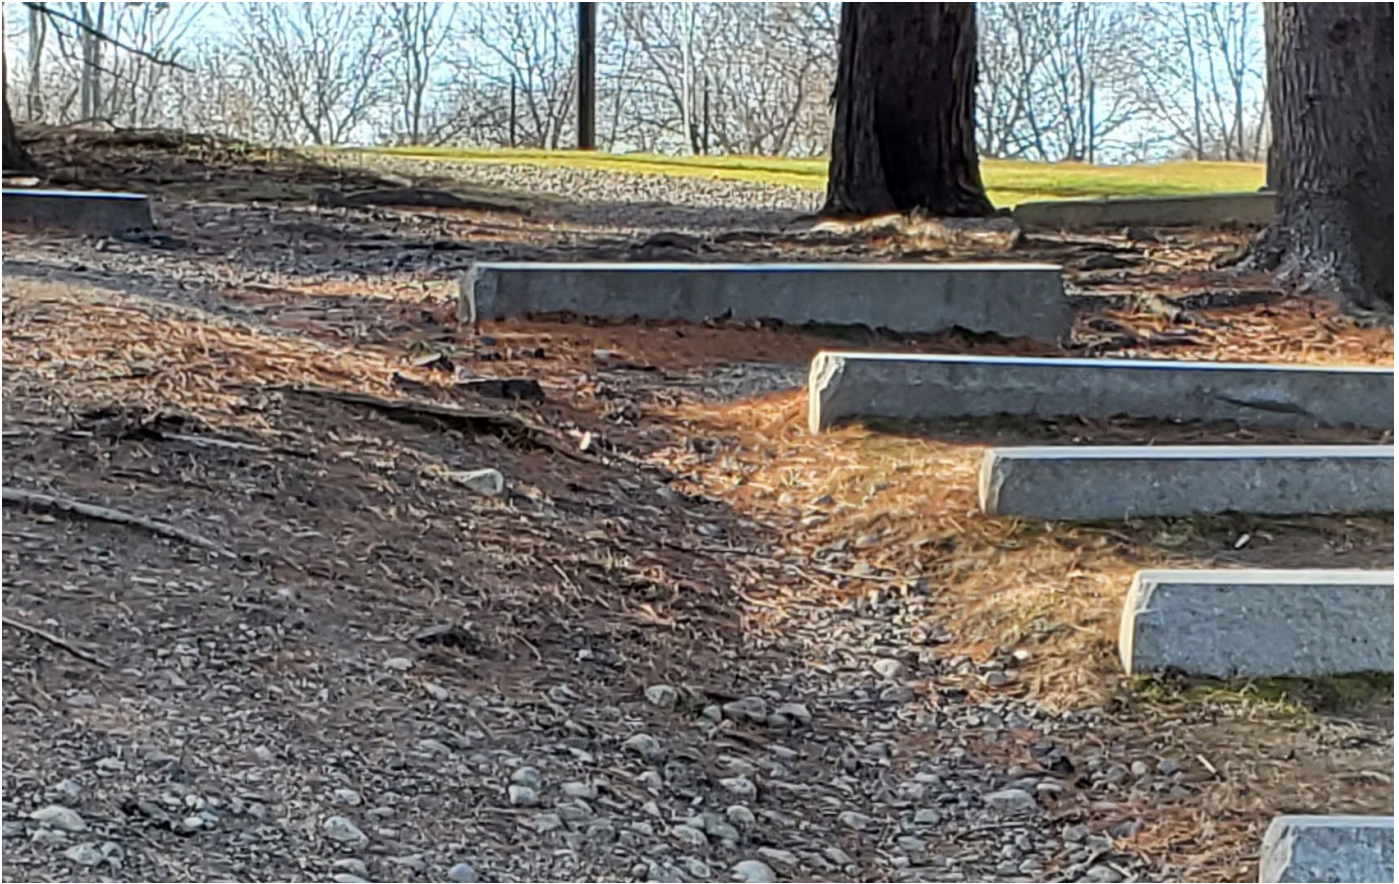
1 Soil Loss from Erosion at Granite Step Treads

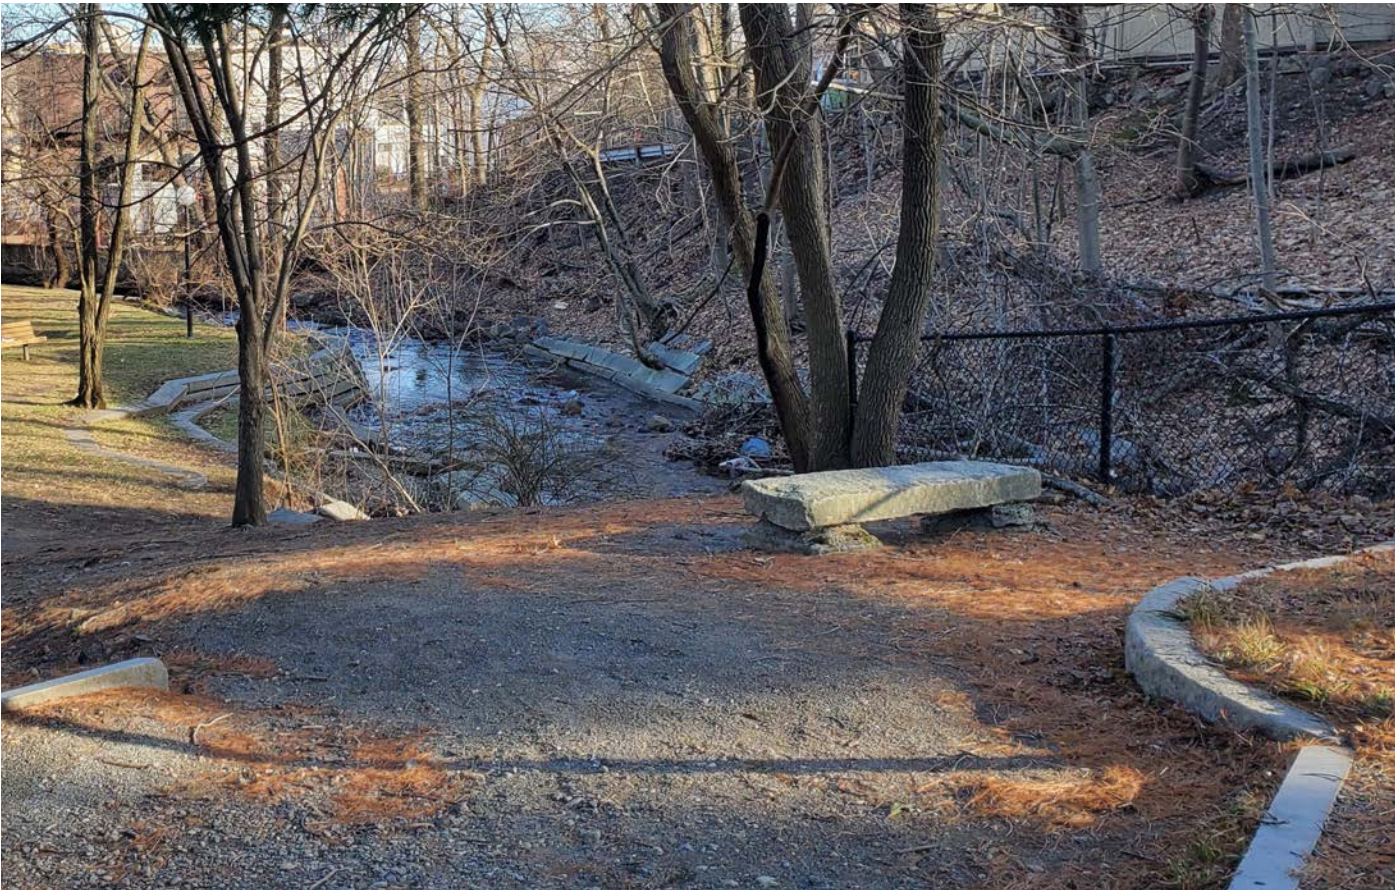
2 Compacted Gravel Slope at Top of Stairs

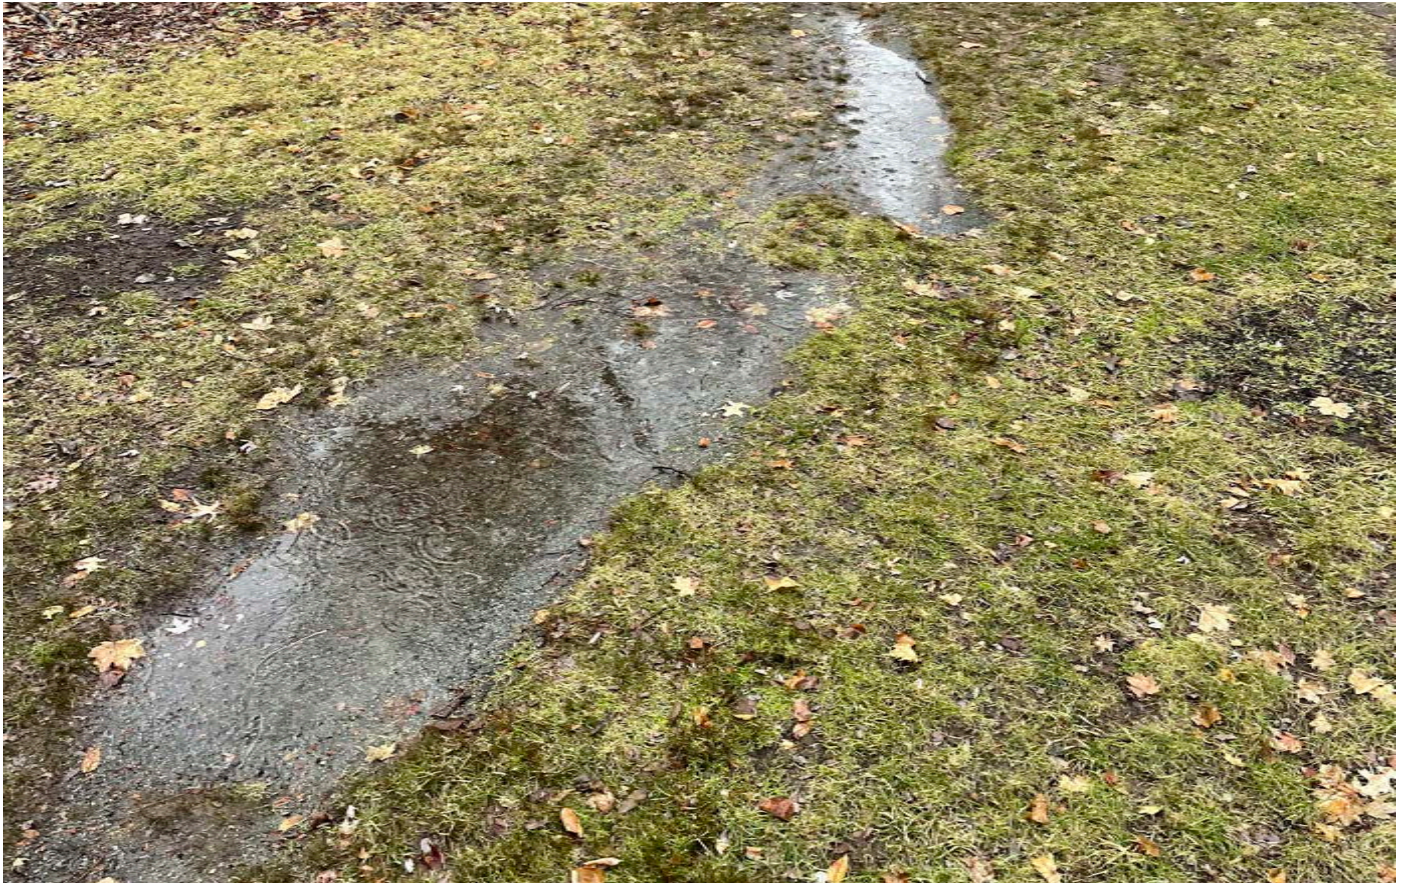
3 Stormwater Runoff Ponding on Compacted Stone Dust Path Surface

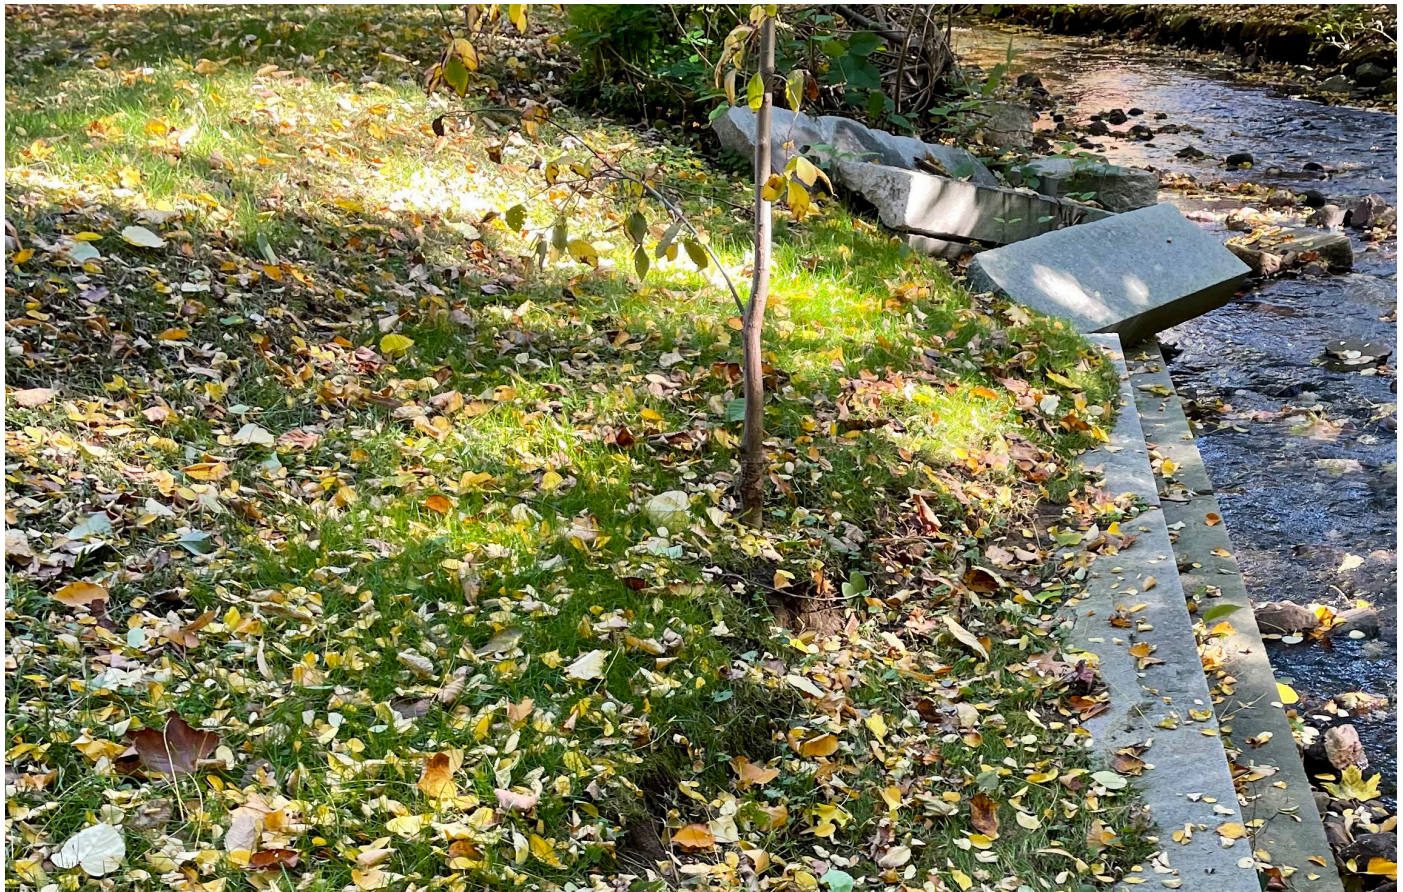
4 Slumping Soil Erosion Behind Granite Curb Edge Near Falls

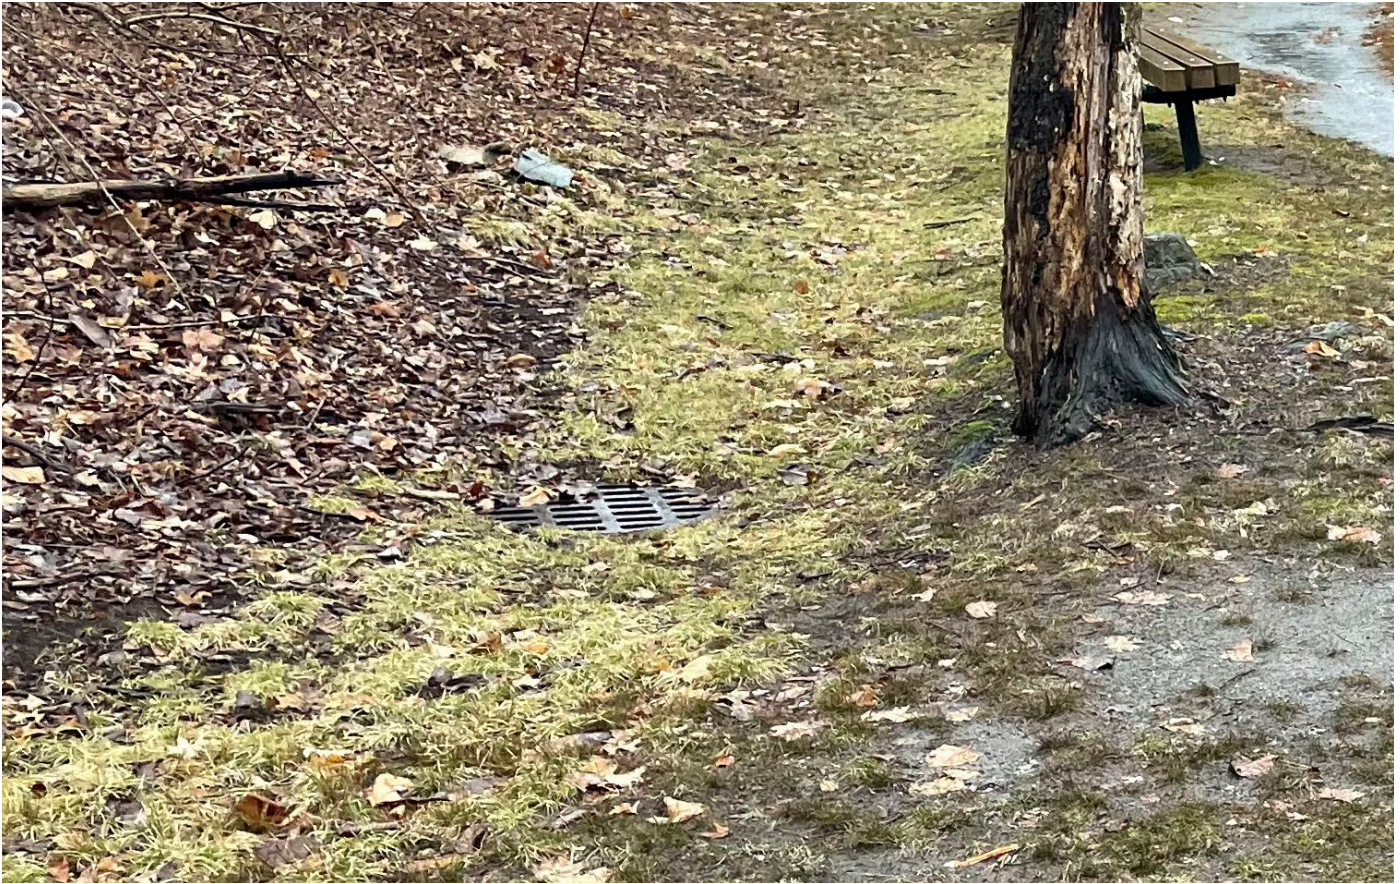
1 Catch Basin Directing Stormwater Runoff Directly to Mill Brook

5. RESTORE BIOSWALE AND REMOVE DIRECT DRAINAGE OUTFALL PIPE TO MILL BROOK.
6. CAPTURE AND INFILTRATE STORMWATER RUNOFF FROM BALL FIELD WITH VEGETATED SWALE AND BIORETENTION BASIN AT BASE OF SLOPE.

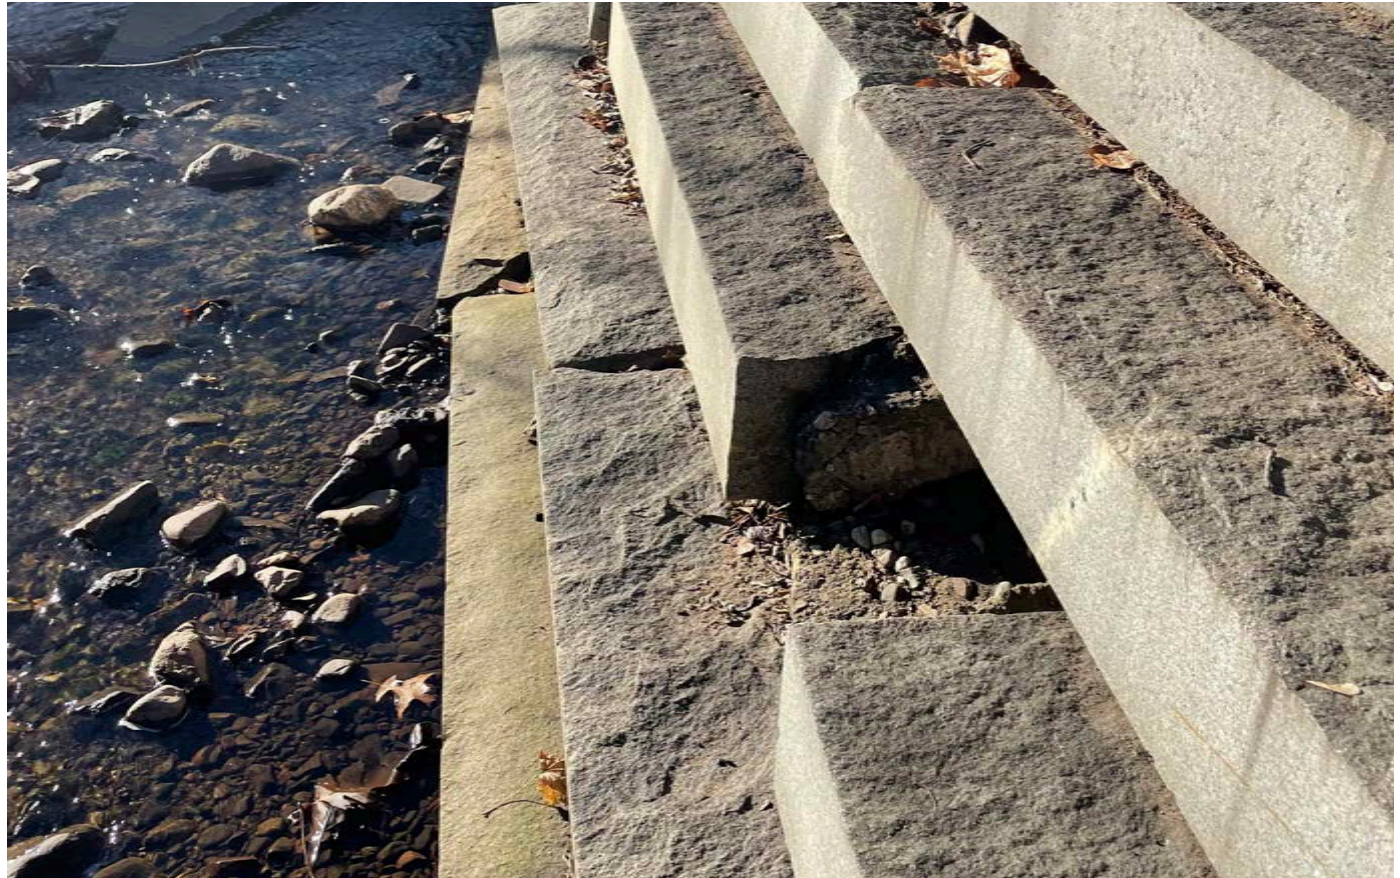
2 Catch Basin Outfall to Mill Brook in Stacked Granite Curb Edge

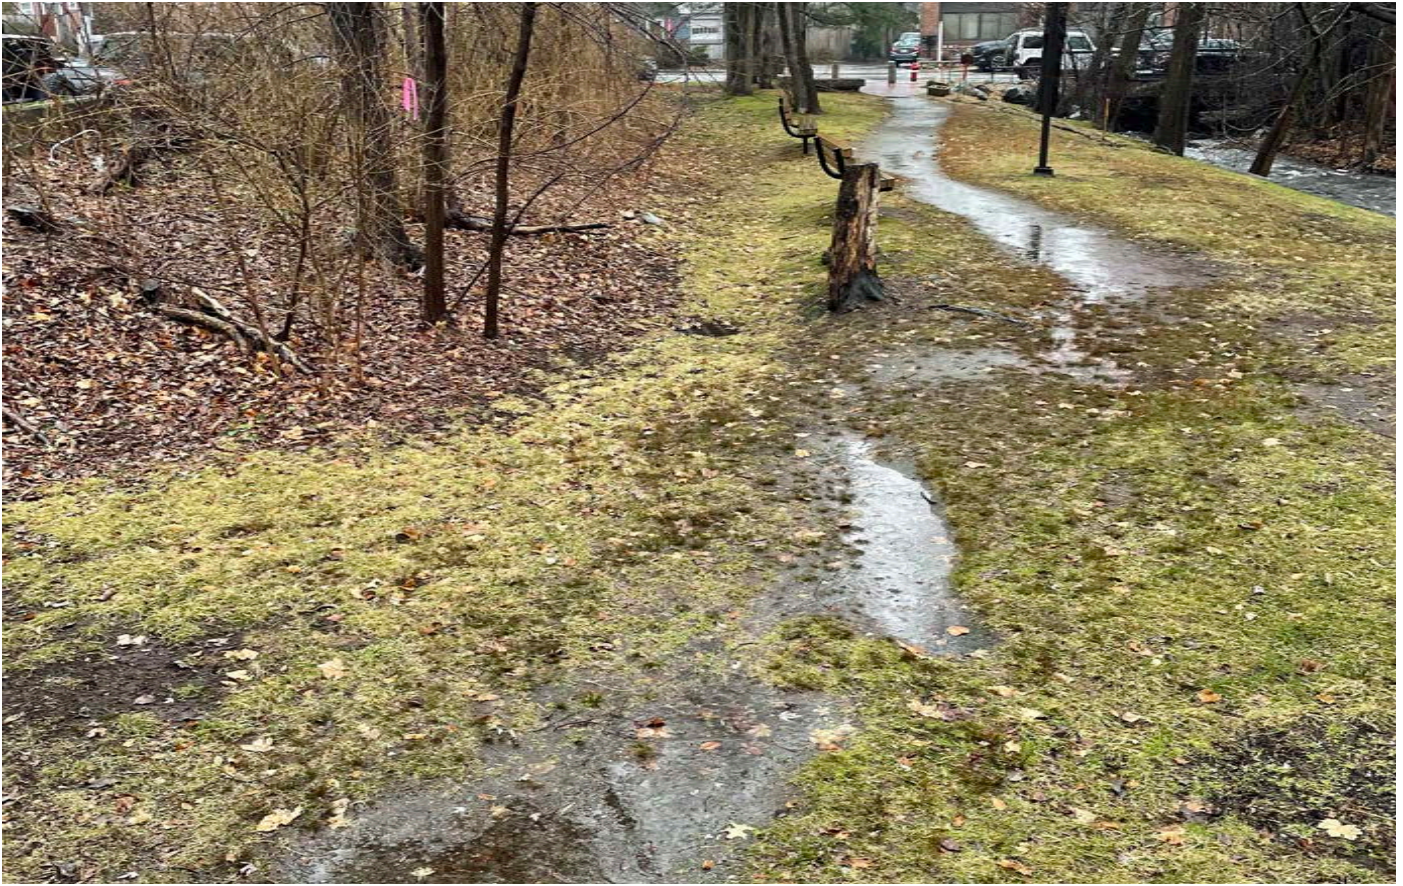
3 Stormwater Surface Runoff Not Being Directed to Swale
